2012 Hazard Log

(Appendix 12D)

Prepared by Anatec Limited Presented to Seagreen Wind Energy Limited Date 05 07 2012 Document Reference A4078-SWEL-NRA-2 App 12D

This appendix presents the Hazard Log for the navigational risks associated with the proposed Phase 1 offshore wind farms (Project Alpha and Project Bravo) and the Transmission Asset Project in the outer approaches to the Firth of Forth and Tay off the east coast of Scotland.

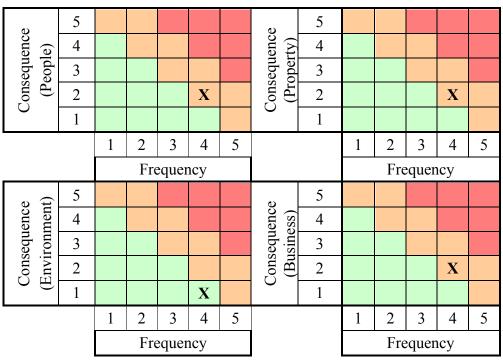
Table 6Risk Matrix: Attendant Vessel Collision with Structure
(Probable Outcome)

Table 6 presents the risk ranking of this hazard for the probable (most likely) outcome.

The risk for the hazard is calculated by averaging the four consequences, i.e., (2+2+1+2)/4 = 1.75) and multiplying by the frequency, i.e., 4, to obtain a risk ranking of 7 (i.e. 1.75 x 4). A score of 7 puts this hazard in the 'Tolerable' region.

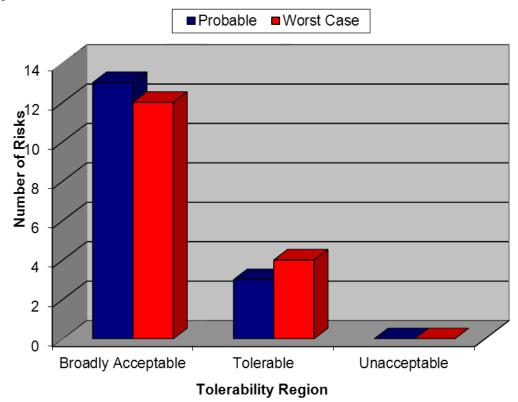
Figure 1 Phase 1 Risk Ranking Results

The overall breakdown by tolerability region was assessed for the 16 hazards and is presented in Figure 1.

No risks were assessed to be unacceptable. As shown in Figure 1, three risks were ranked within the 'Tolerable' region based on the probable outcome whilst four were ranked as 'Tolerable' based on the worst case outcome.
